Trip Report on Microbeam Testing of SiGe Heterojunction Bipolar Transistors (HBTs) Fabricated in IBM 5HP, 6HP and 7HP

Robert A. Reed¹, Paul W. Marshall², Guofu Niu³, John Cressler⁴, Gyorgy Vizkelethy⁵,
Paul Dodd⁵, and Ramkumar Krithivasan³, Nilesh Shah⁶

REPORT DATE: 9/30/02

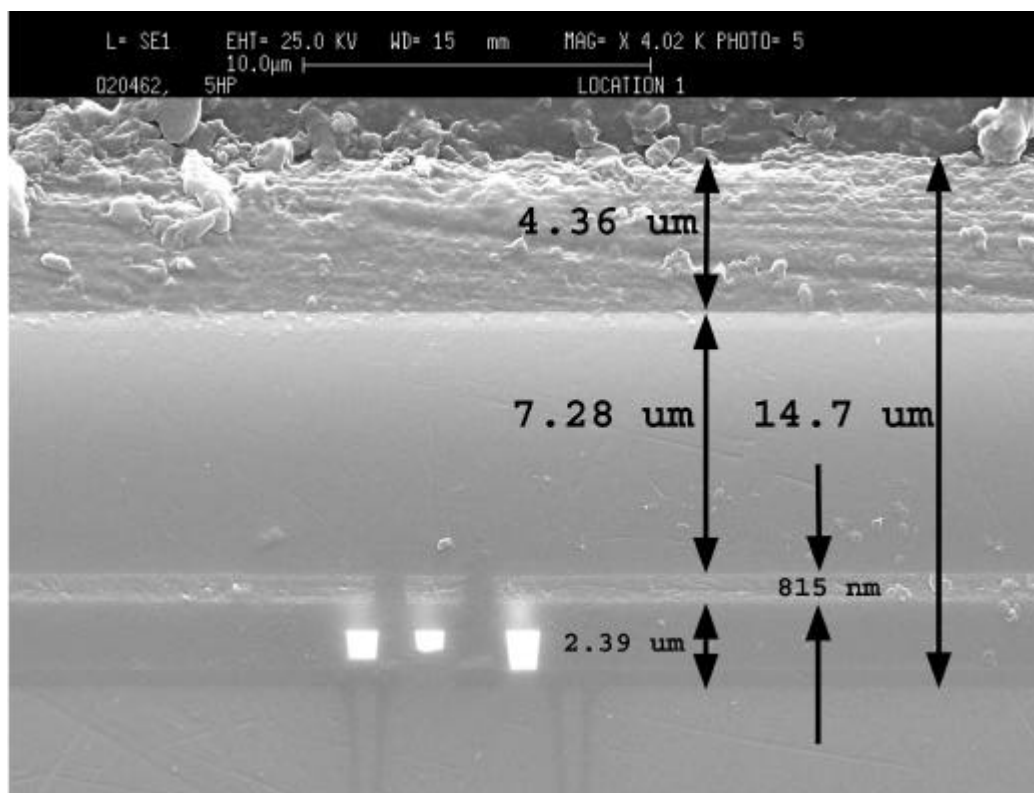
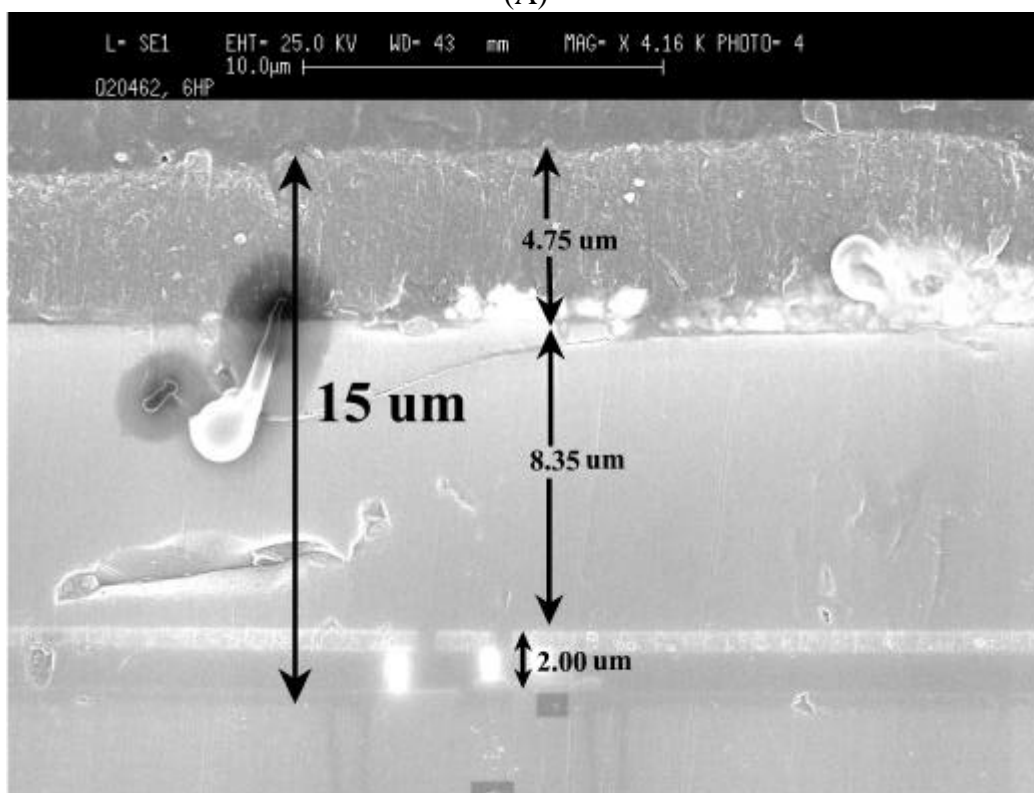
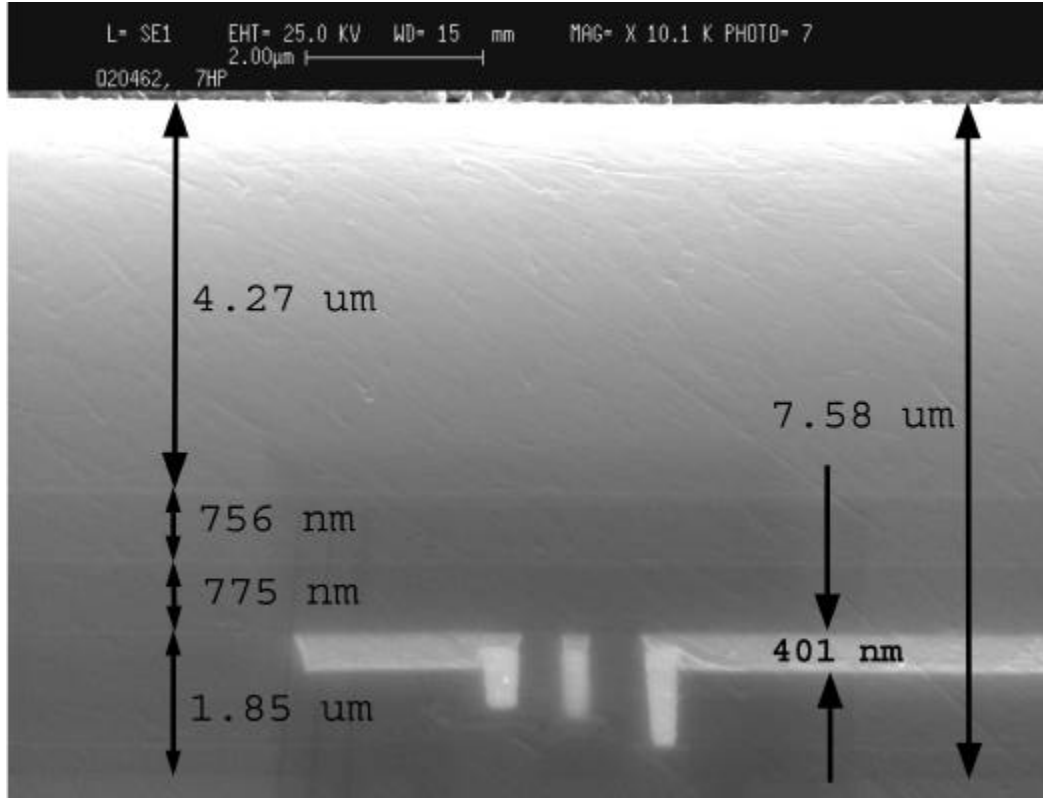
Figure 1. SEM of (A),5HP, (B) 6HP and (C) 7HP HBT transistor cross-section.

Prior to microbeam testing, Tx cross-sectioning and SEM images (SEMs) were preformed at GSFC. The three images in Figure 1 show the SEMs for the 5HP, 6HP and 7HP, respectfully. An ~5 μm polyimide coating is evident in the 5HP and 6HP SEMs. While not shown in the image, the polyimide coating was also on the 7HP die. Each die was exposed to a chemical vapor etch process to remove the polyimide. This etch is required so that ions can penetrate into the Tx substrate. While most of the 24 Txs survived the etch process, 7 were damaged to the point were they could not be used for SEU testing. These are noted in Table 3 in the Test Summary section.

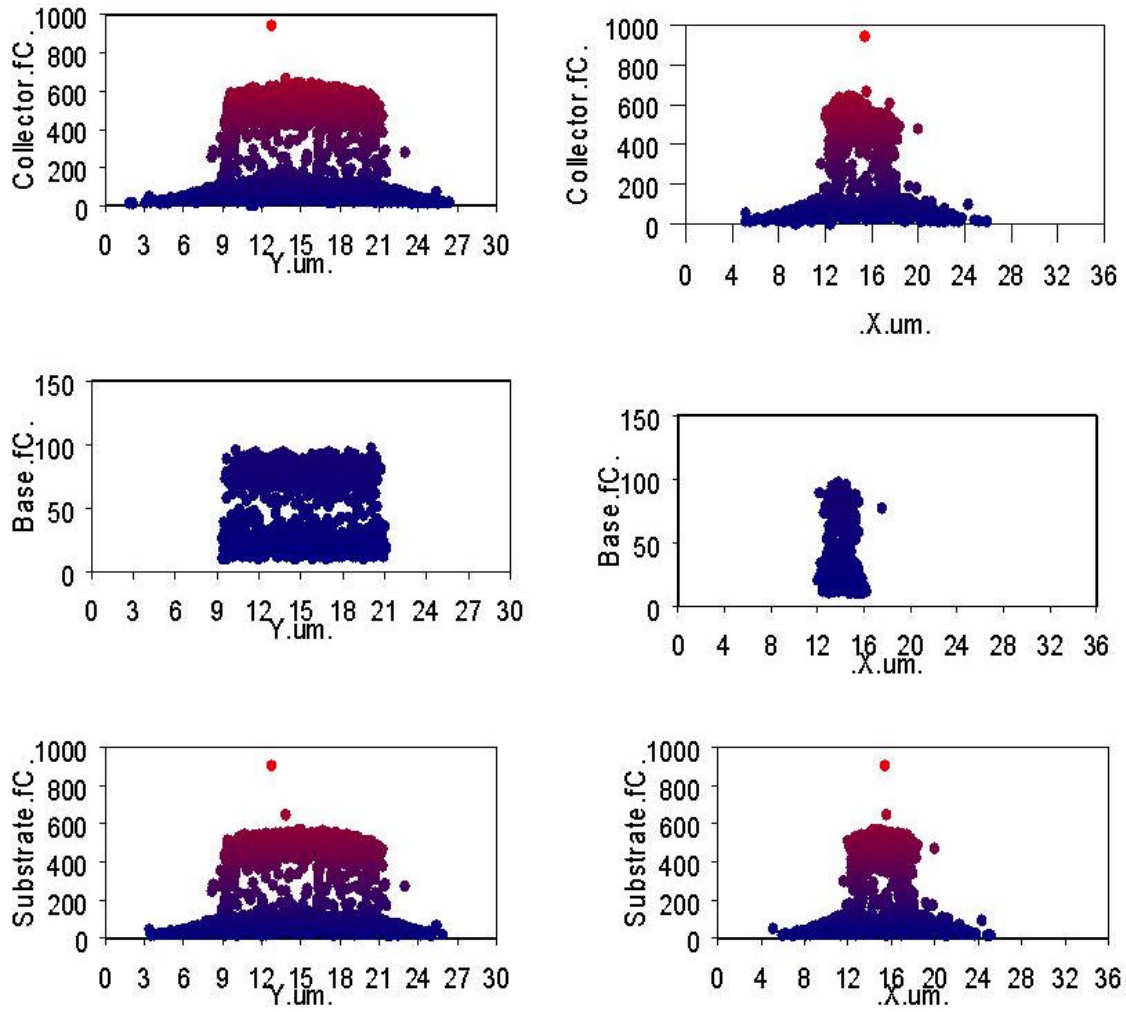
Figure 1. Charge collection results for base, collector and substrate contact for 5HP 0.5 μ m x 10 μ m transistor.

Figure 1 shows charge collection results obtained on the collector, base and substrate contacts for a 5HP 0.5μm x 10μm transistor. Figure 2 is a 3D plot of the same including the emitter. No charge was observed on the emitter contact. Further analysis is underway for other transistors.
